NUCLEAR WEAPONS EFFECTS TESTS  
OF BLAST TYPE SHELTERS

A Documentary Compendium of Test Reports

# **NUCLEAR WEAPONS EFFECTS TESTS OF BLAST TYPE SHELTERS**

**A Documentary Compendium of Test Reports**

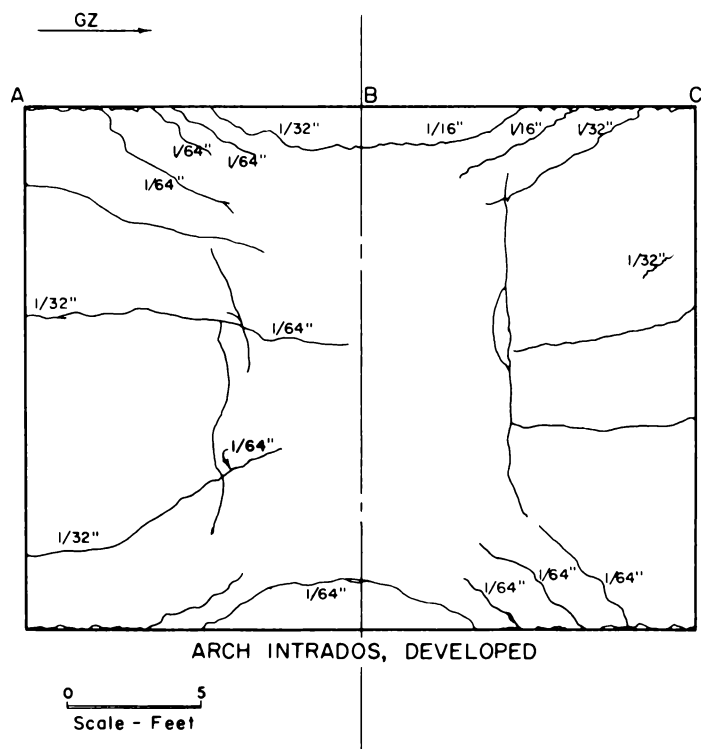
NOTE: All Crack Widths Not Noted Are Less Than  $\frac{1}{64}$  Inch Wide.

Fig. 10—Postshot crack survey, structure 3.1c.

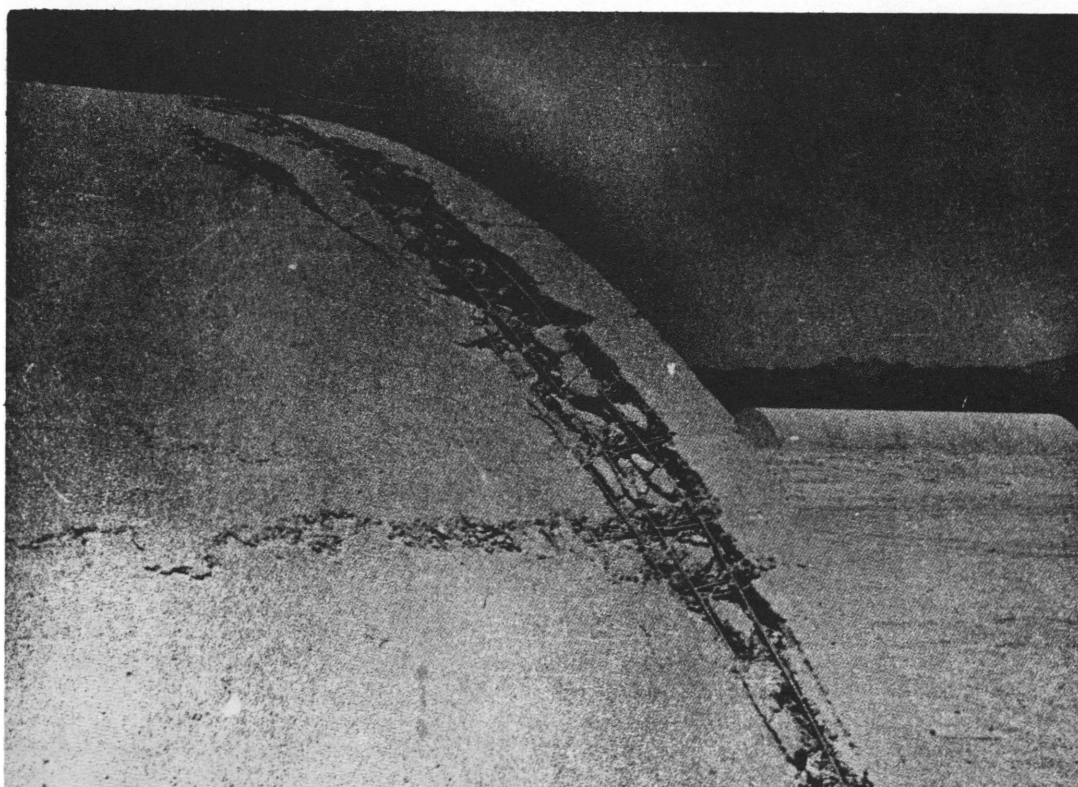
Fig. 12—Damage to side of concrete arch facing GZ at 70-psi overpressure region.

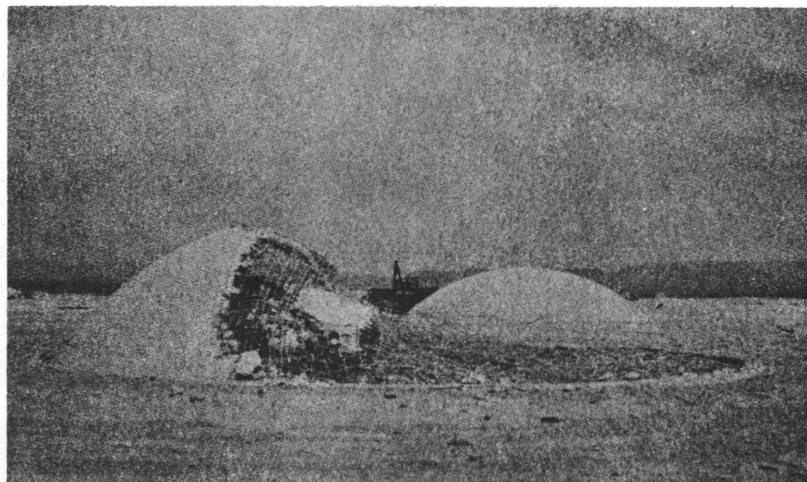
**Fig. 13—Left side of responding concrete dome at 70-psi overpressure region.**

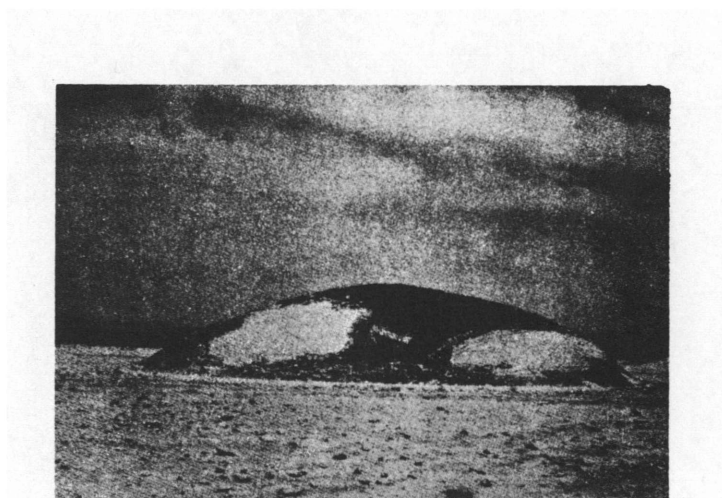
**Fig. 14—Damage to responding concrete dome at 35-psi overpressure region, showing side of dome facing GZ.**

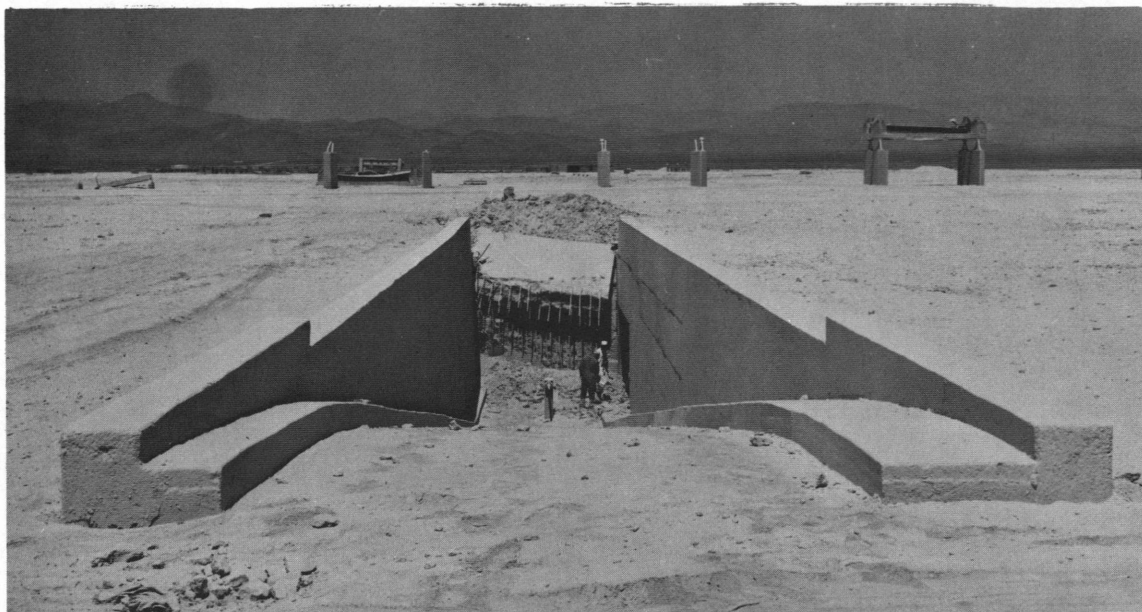
Fig. 1—View of ramp looking toward damaged end wall, postshot.

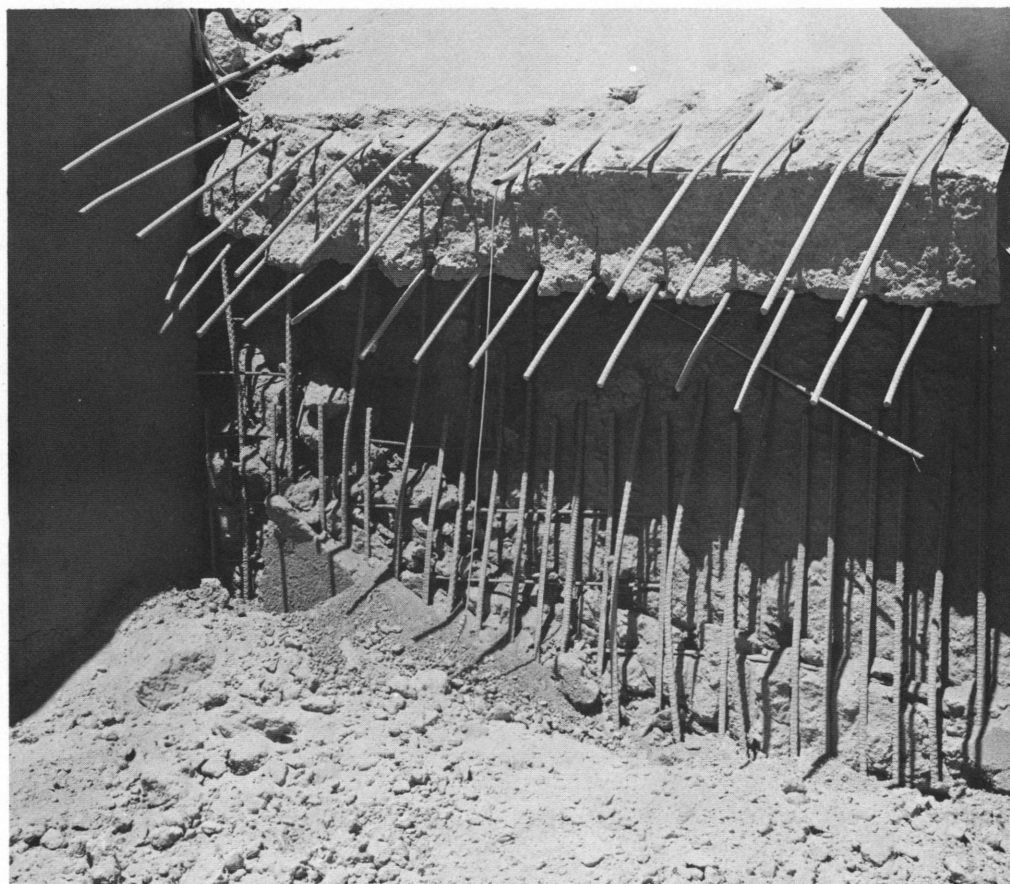
Fig. 2—Detail of failure showing fractured bars, postshot.

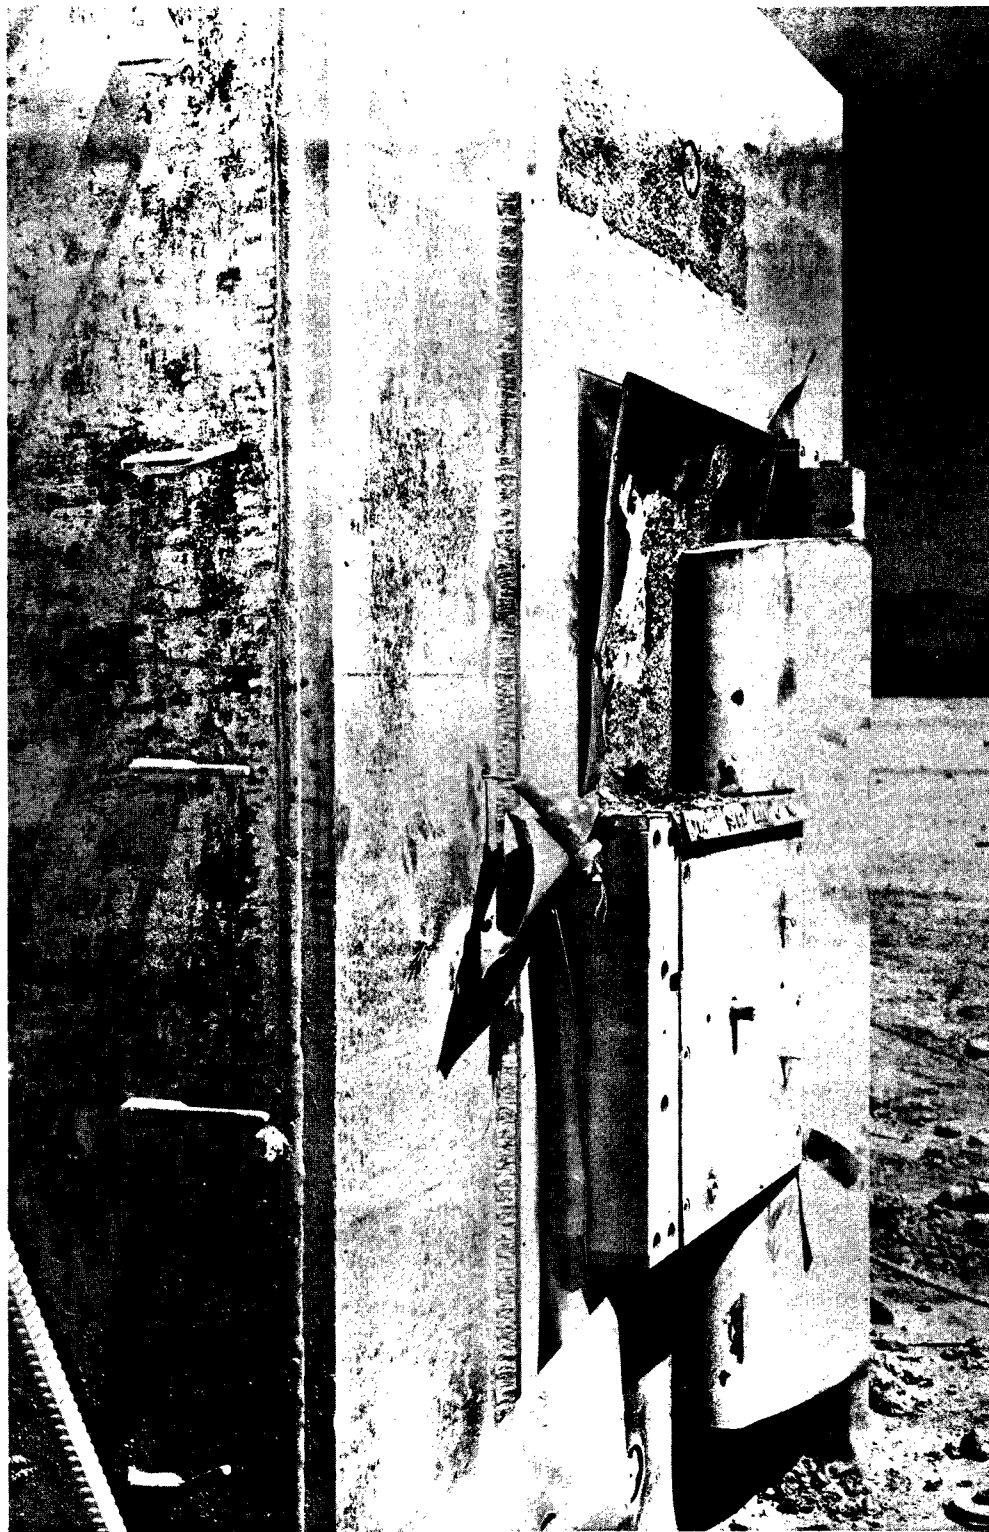
Fig. 6—Close-up view of front face from south showing damage to light-gauge finish plates and hardware, postshot.

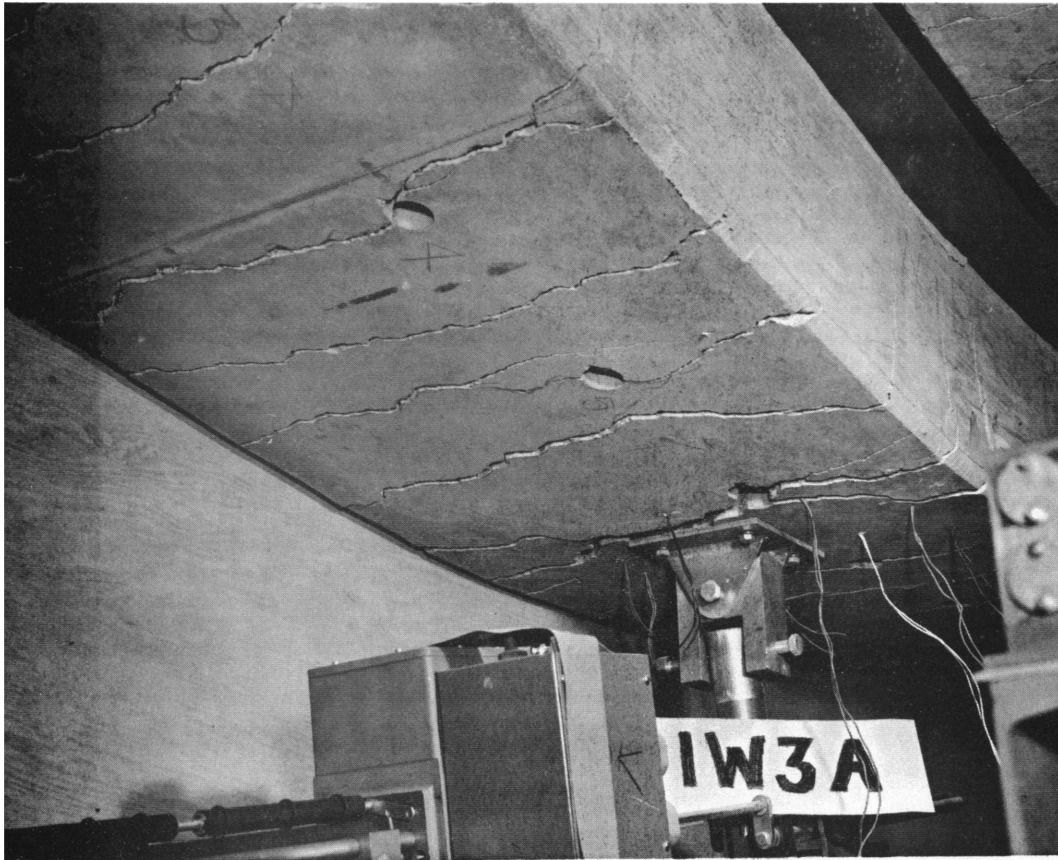
**Fig. 5**—Photograph showing tension cracks beneath slab IW3A.

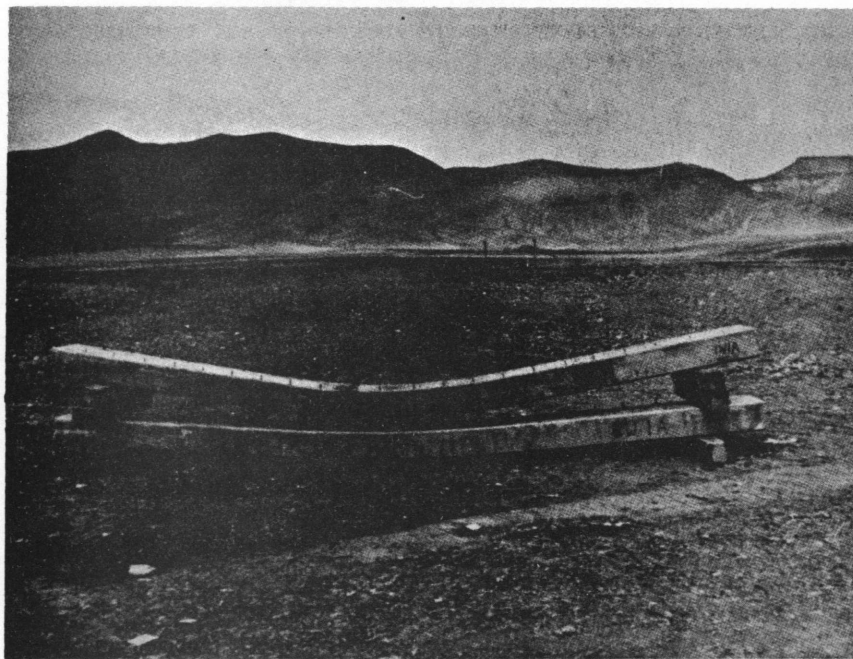
**Fig. 6**—Slabs IW1A and RW1A, showing relative permanent displacement and tension crack pattern (IW1A on top).

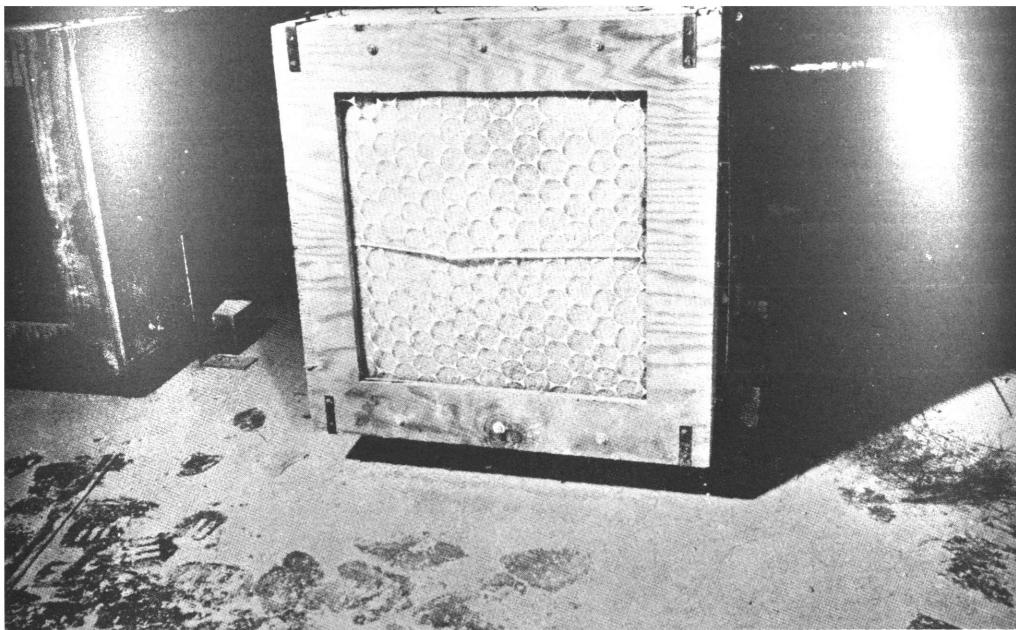
Fig. 10—Dust-Stop filter in hood 3 in chemical plant, postshot.

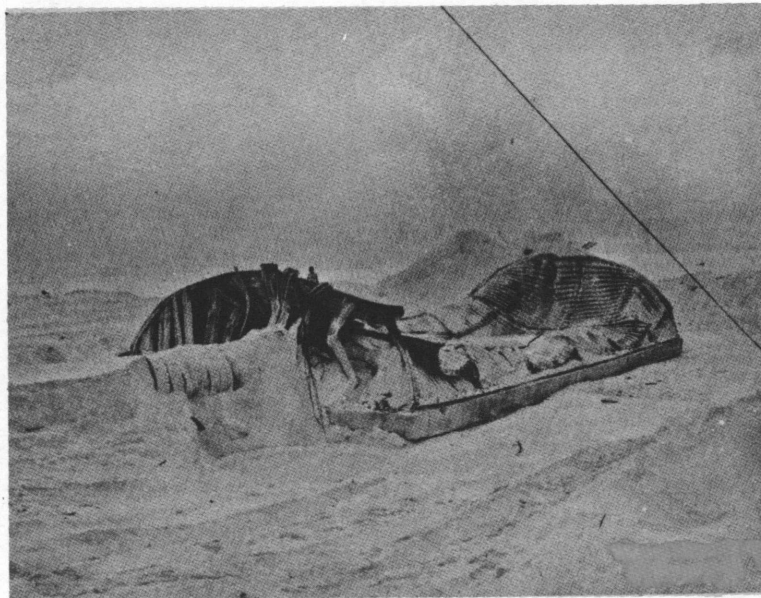
Fig. 13—Structure 3.2c, damaged end walls; GZ to left.

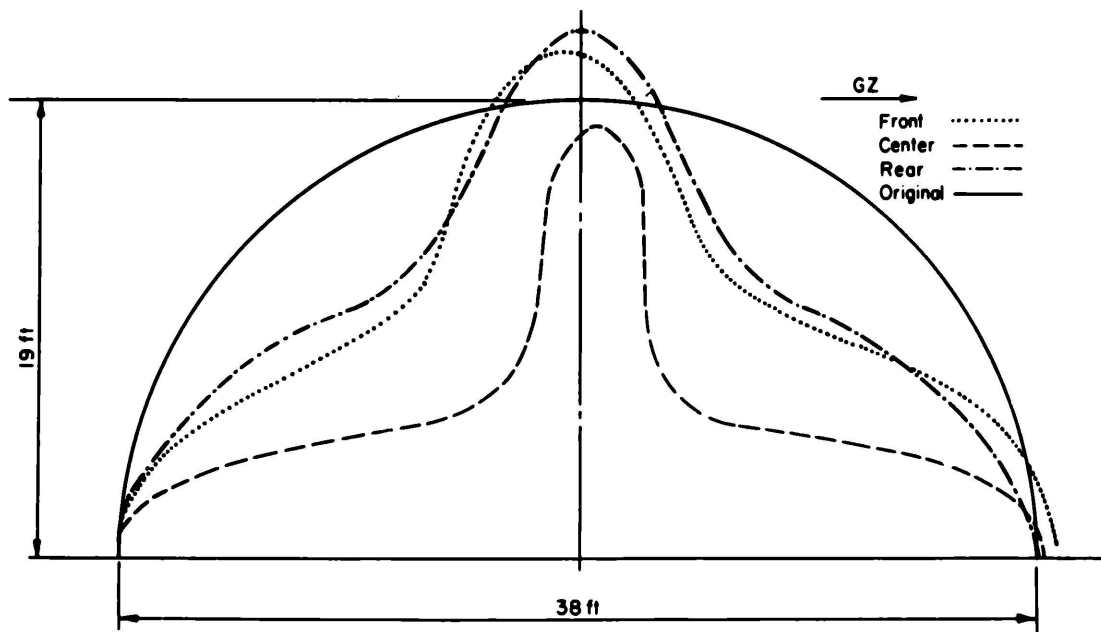
Fig. 14—Structure 3.2d, profiles of deformed arch shell at front, center, and rear.

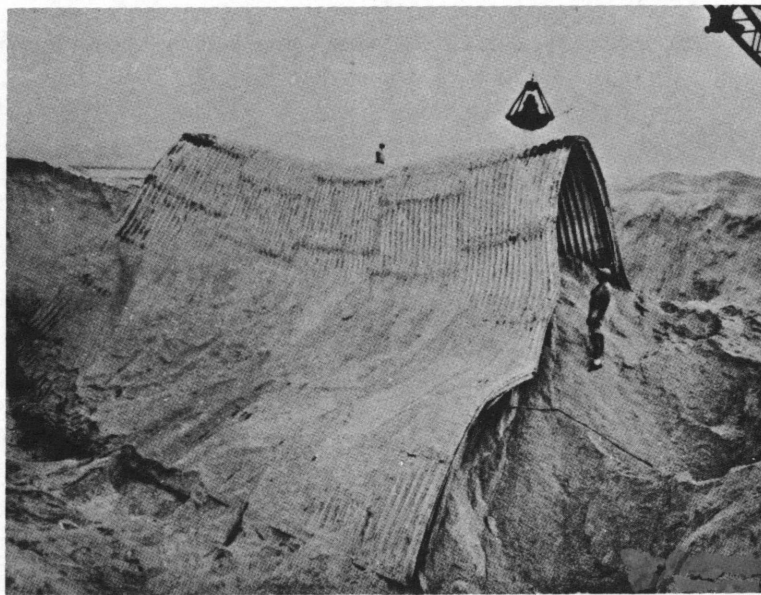
Fig. 15—Structure 3.2d, infiltration of sand after end-wall failure; looking toward GZ.

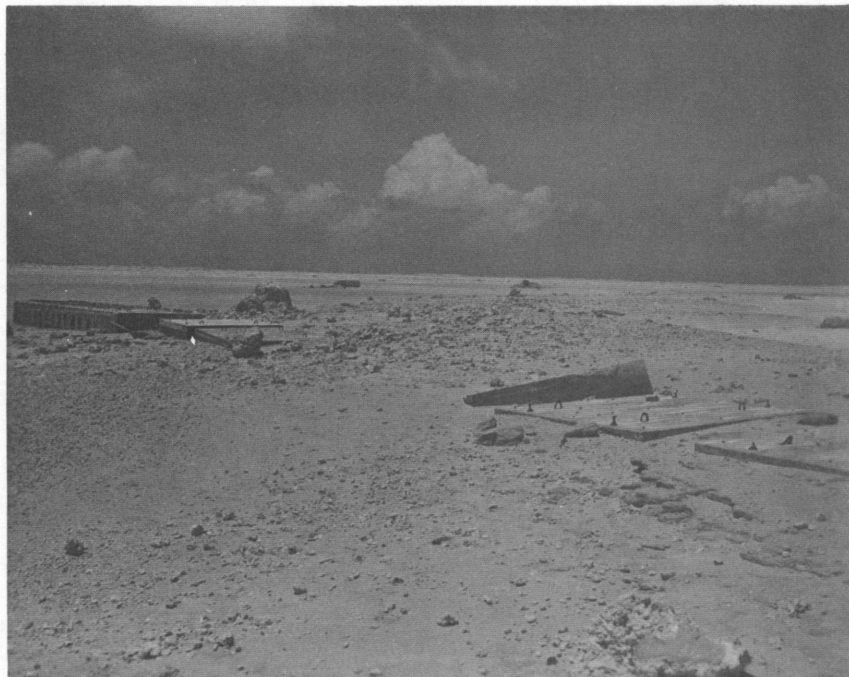
**Fig. 10—Posttest view of two-way slabs at station 360.01, range 1830 ft, looking away from GZ, showing evidence of foundation failure.**

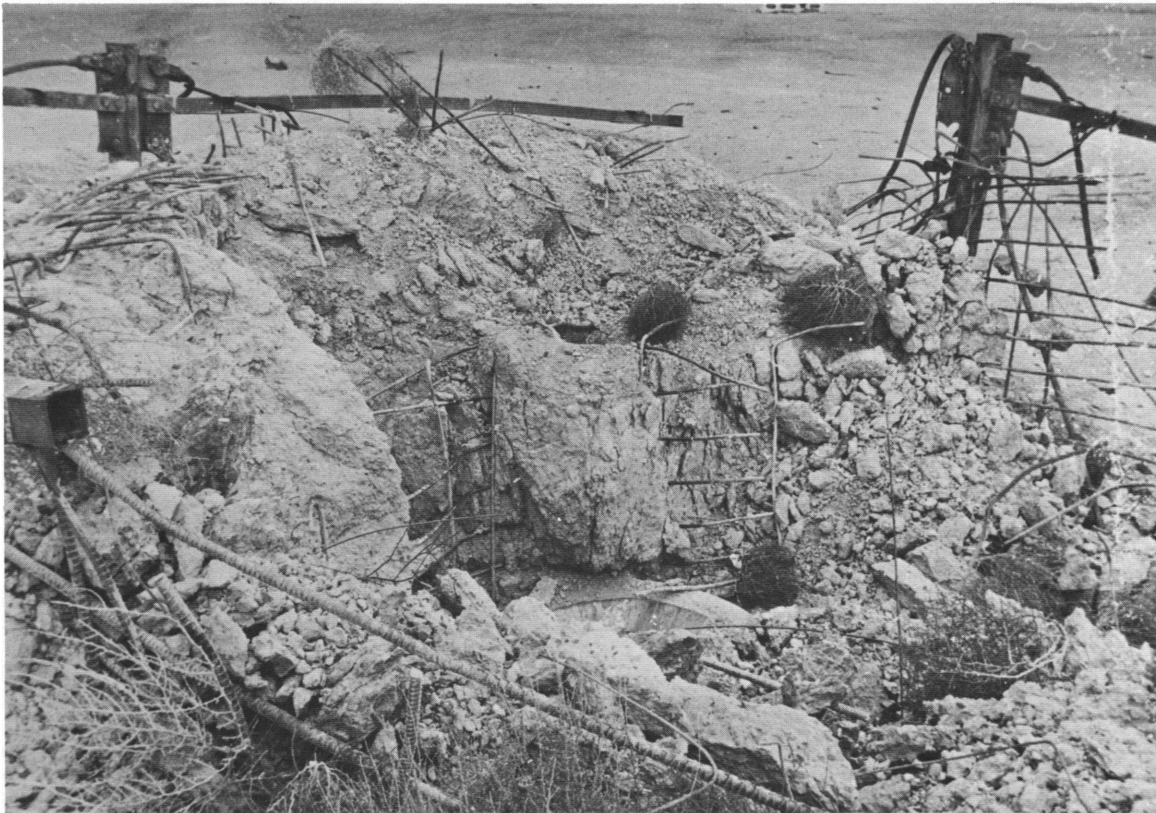
Fig. 7—Post-Quay event damage to tower base.

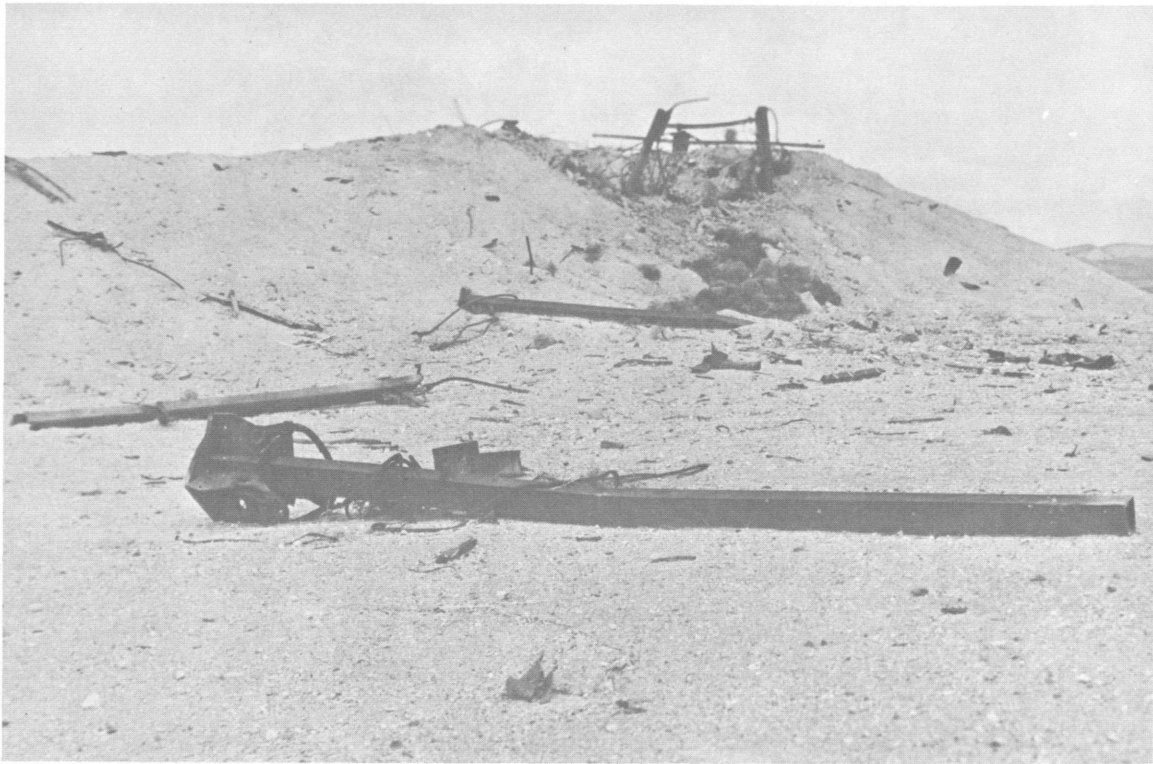
Fig. 8—Post-Quay event damage, horizontal view of tower-base area.

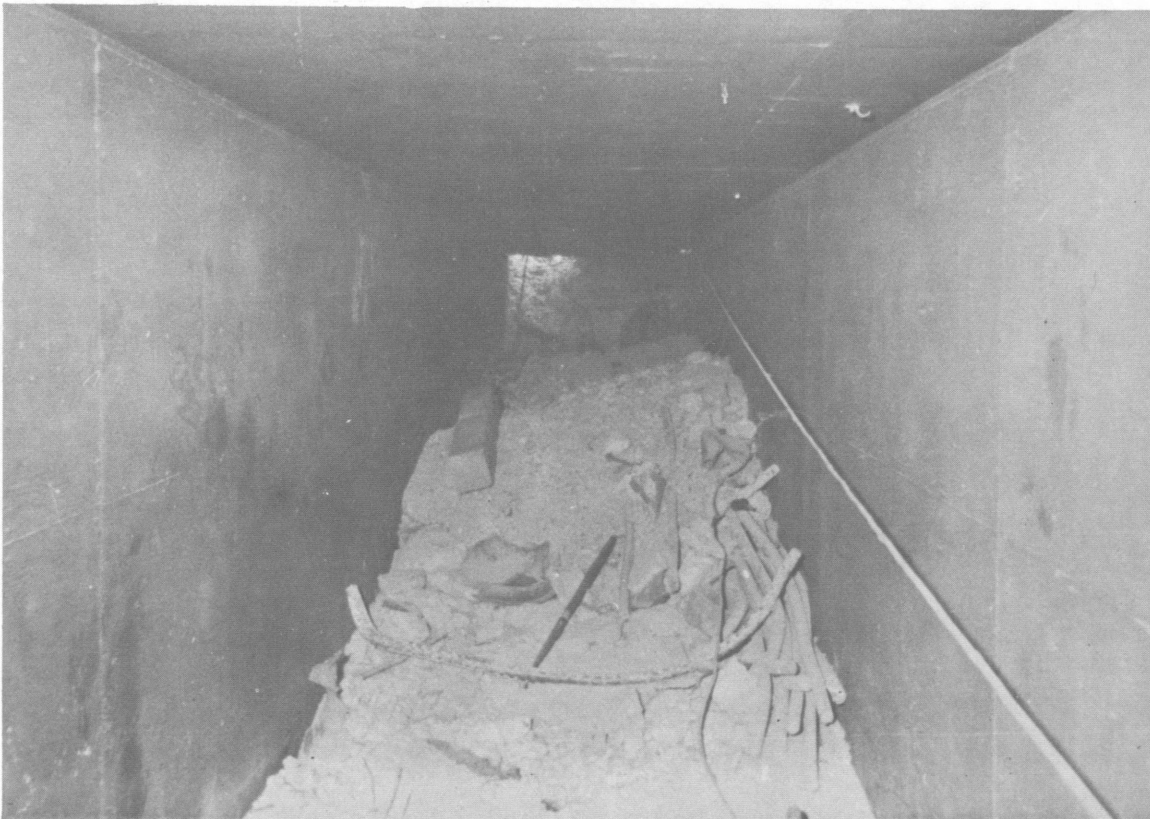
Fig. 9—Post-Quay event damage to tower-base tunnel.

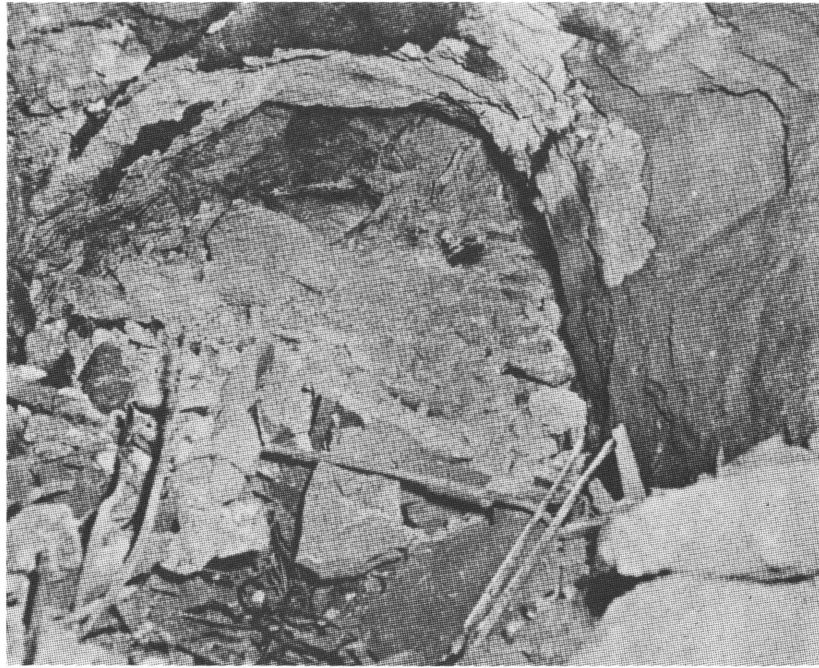
Fig. 6—Point of closure, drift U12b.02, Tamalpais event.

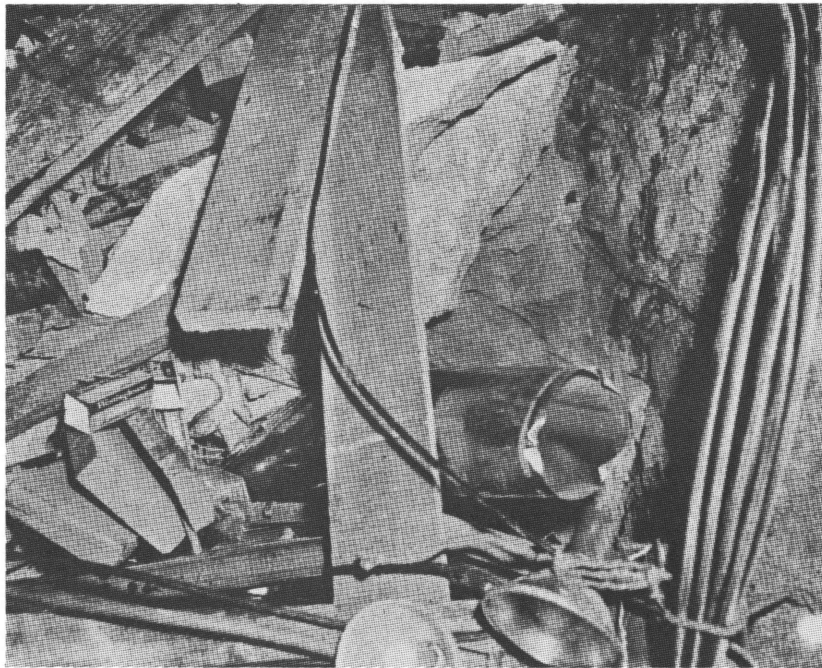
Fig. 7—Damage to alcove 1, drift U12b.02, Tamalpais event.

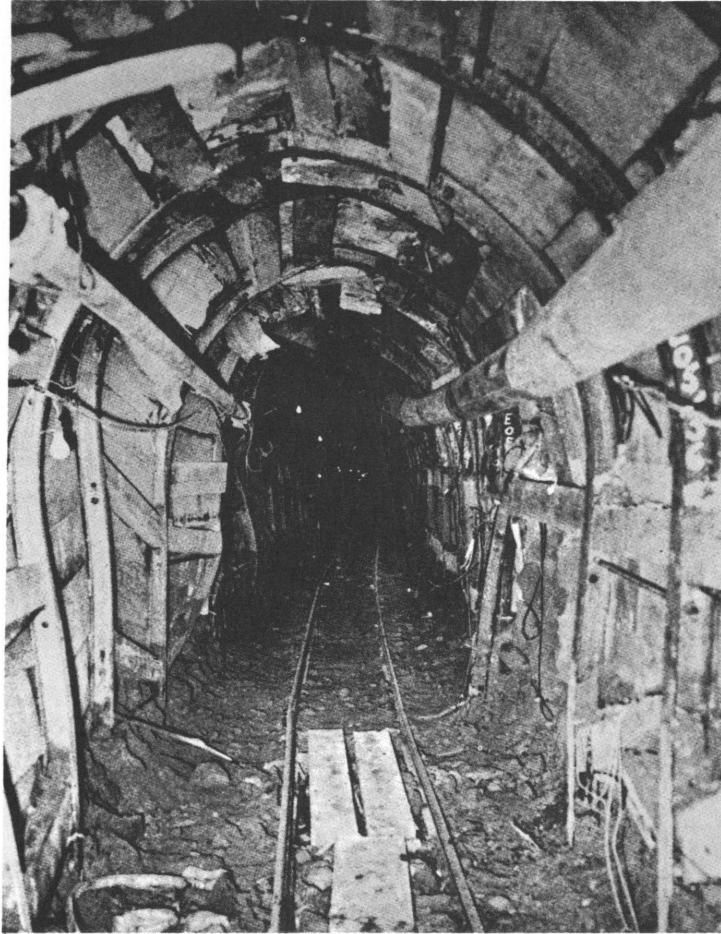
Fig. 8—Typical damaged section, drift U12e.05, Logan event.

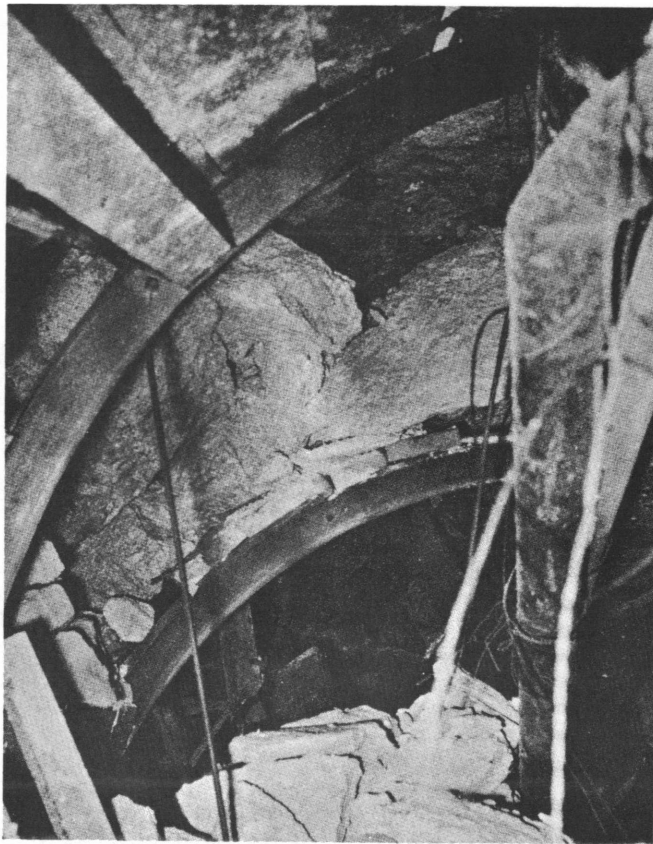
Fig. 9—Point of closure, station 16+70, tunnel U12e, Blanca event.
